NASA CONTRACTOR REPORT 159057

MODIFIED CARBON FIBERS TO
IMPROVE COMPOSITE PROPERTIES

R. E. SHEPLER

UNION CARBIDE CORPORATION
CARBON PRODUCTS DIVISION
PARMA TECHNICAL CENTER
PARMA, OHIO

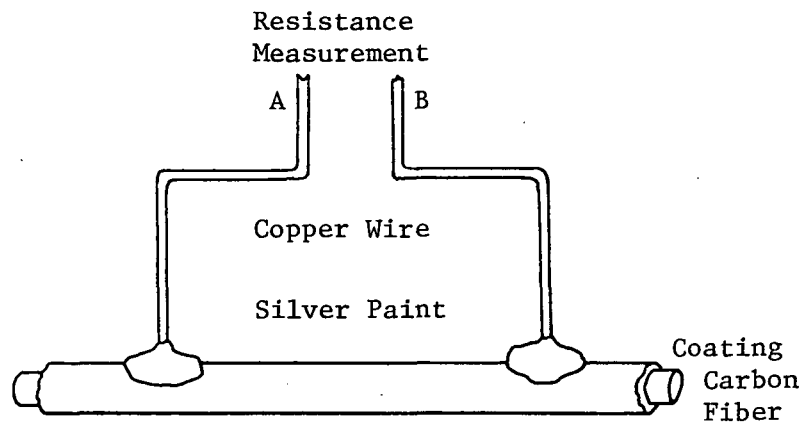
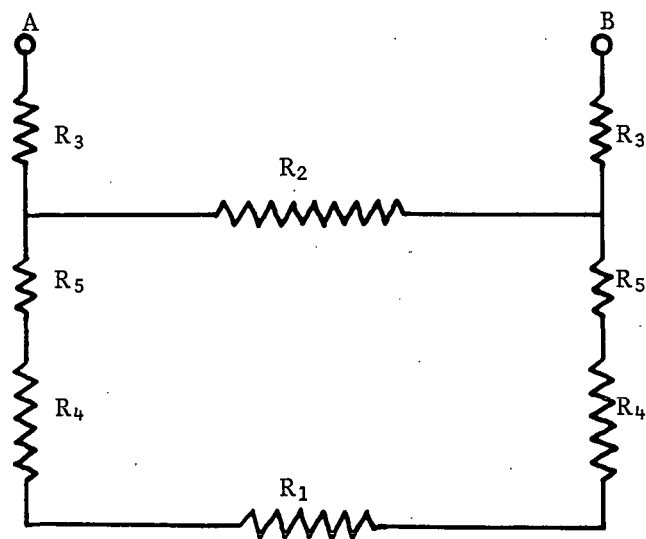
Figure 3-3. The Measurement of the Electrical Resistivity of a Coated Carbon Fiber can be Schematically Represented as shown where:

- R_1 = resistance of fiber,
- R_2 = resistance of coating,
- R_3 = contact resistance between probe and coating,
- R_4 = contact resistance between coating and fiber,
- R_5 = resistance radially through coating.

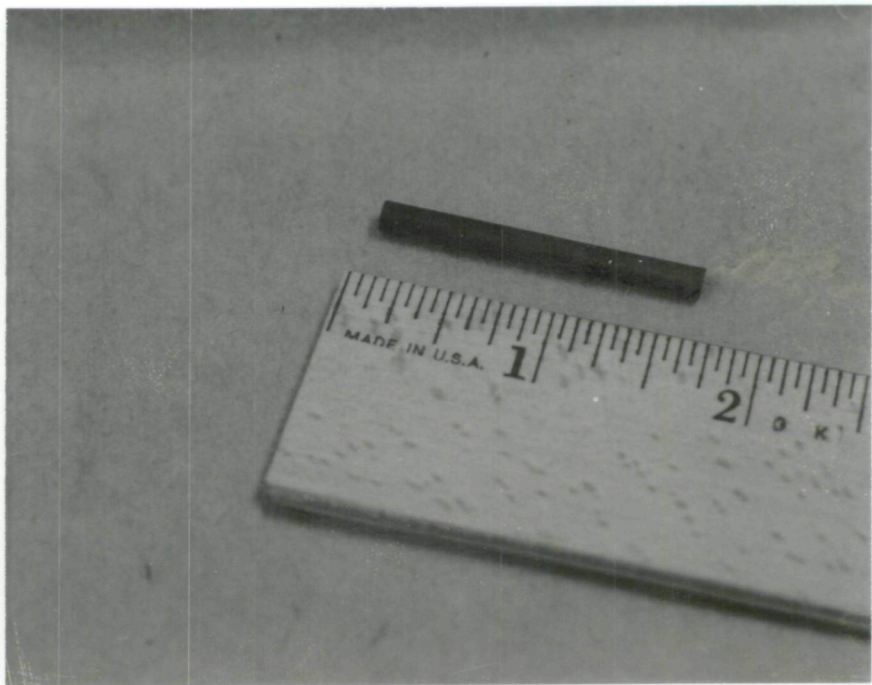
Fig. 3-1

Fig. 3.1. Torsion Rod Specimen. Scale
in Inches.

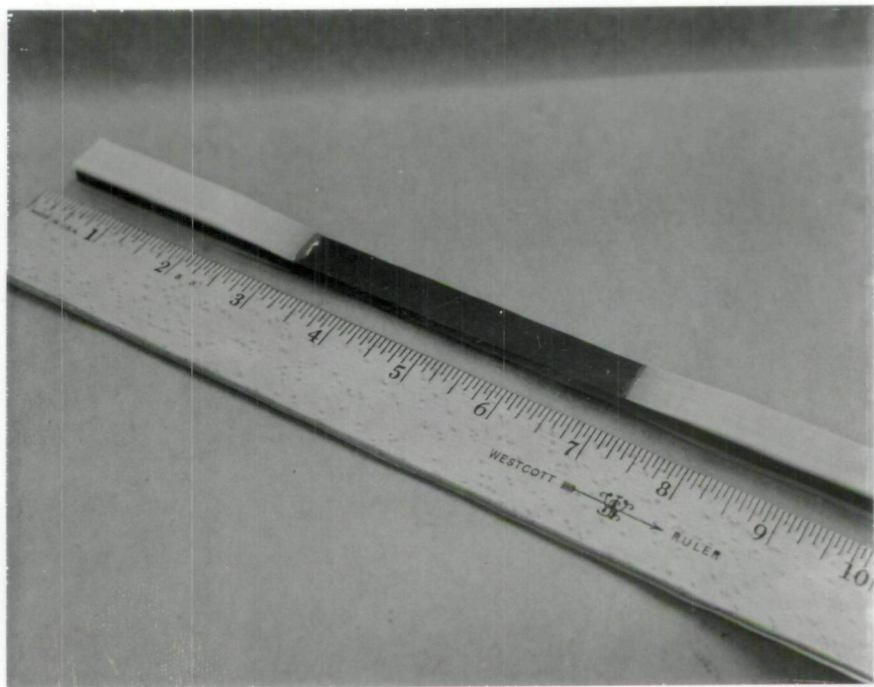
Fig. 3.2(a) Tensile Specimen with
Fiberglass Tabs.

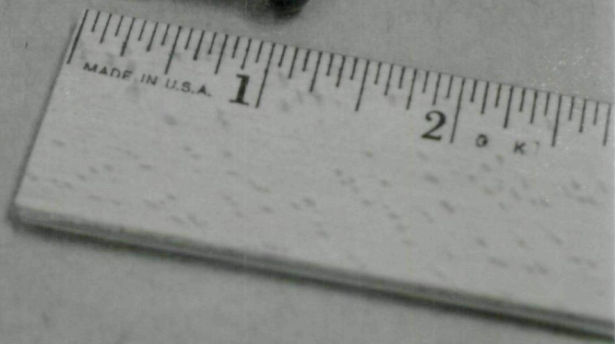
Fig. 3-2(b)

Fig. 3.2(b) Texaco Compression Sample.

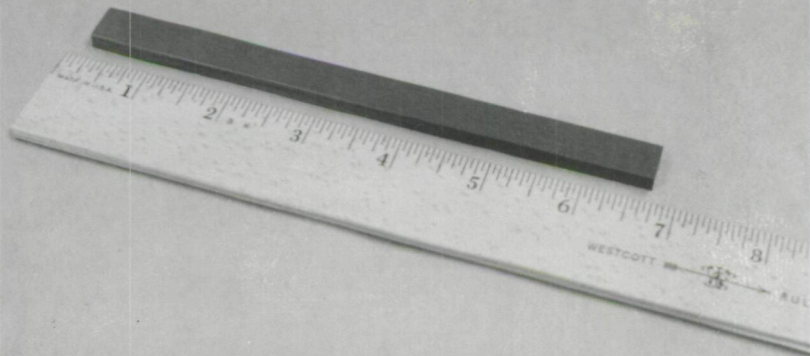
Fig. 3.2(c) Flexural Specimen

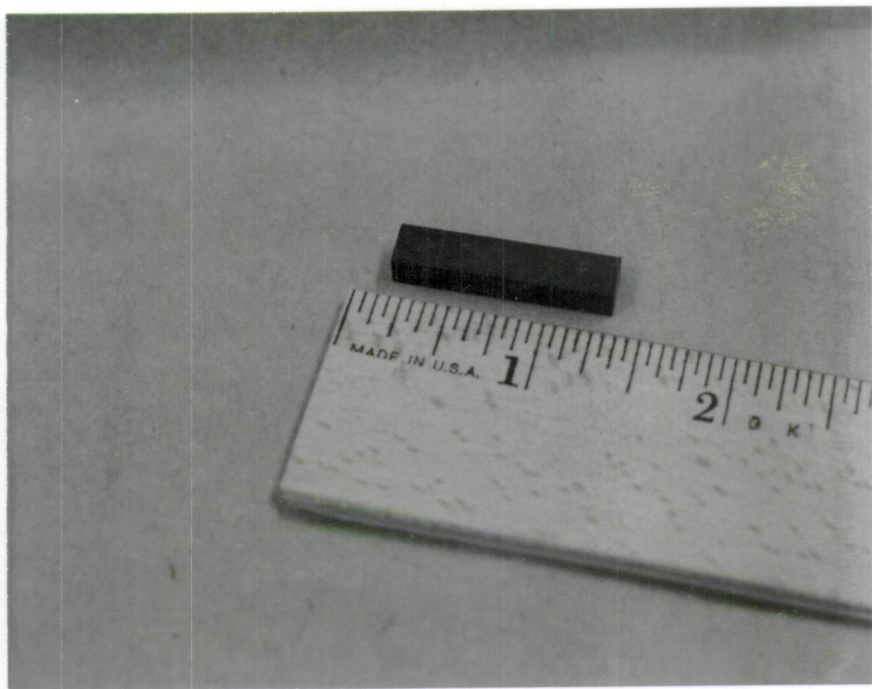
Fig. 3-2(d)

Fig. 3.2(d) Short Beam Shear Sample

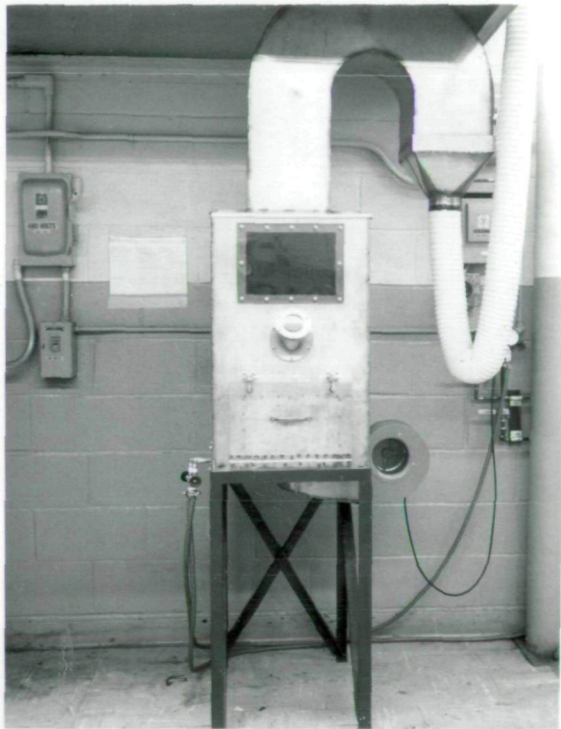
Fig. 3.4(a) Chamber showing
Collection System.

A chamber was built to burn test composite plates made with the coated carbon fibers, see Figure 3-4. The chamber consists of a stand to hold the composite plate, a gas fired torch to heat the plate, a device to drop weights on the plate, a fan to blow air across the plate, and a vented exhaust system with a filtered collector to gather airborne debris from the burn test. Conditions in the chamber were

The chamber was made of stainless steel to make cleaning between tests easier and an access door in the front and a hinged top also facilitated cleaning. It was necessary to clean the chamber before testing each new sample so debris collected could be assured to be from the sample under test. A large window made it easy to view the sample under test while a smaller quartz glass window was used in sighting on the sample with a pyrometer.

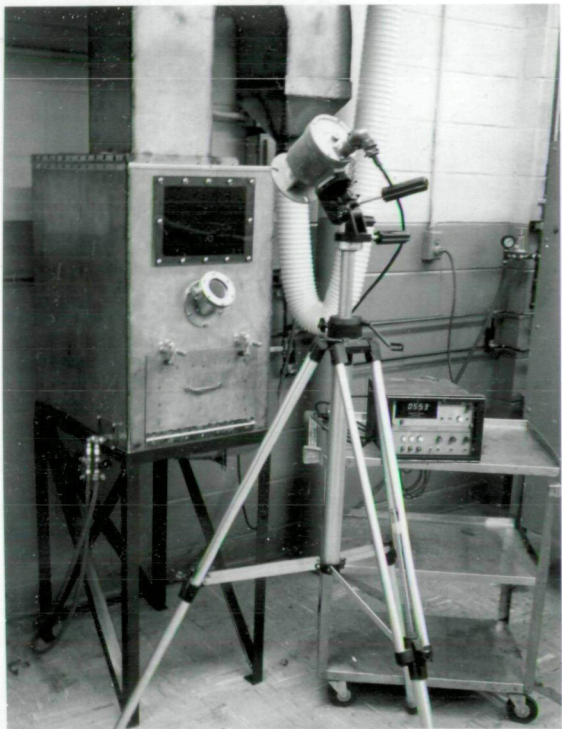
Fig. 3-4(b)

Fig. 3.4(b) Temperature
Measurement

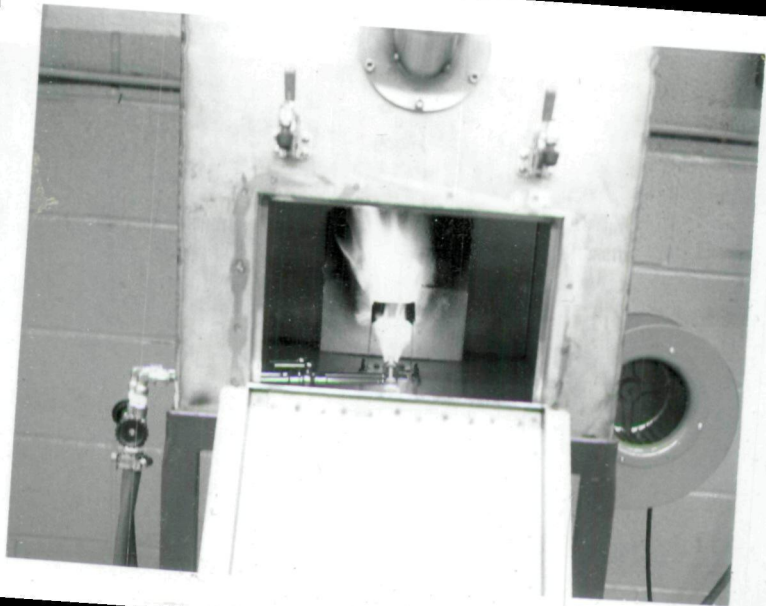
Fig. 3.4(c) Sample Under Test

Fig. 3.4. Dynamic Burn Test
Chamber.

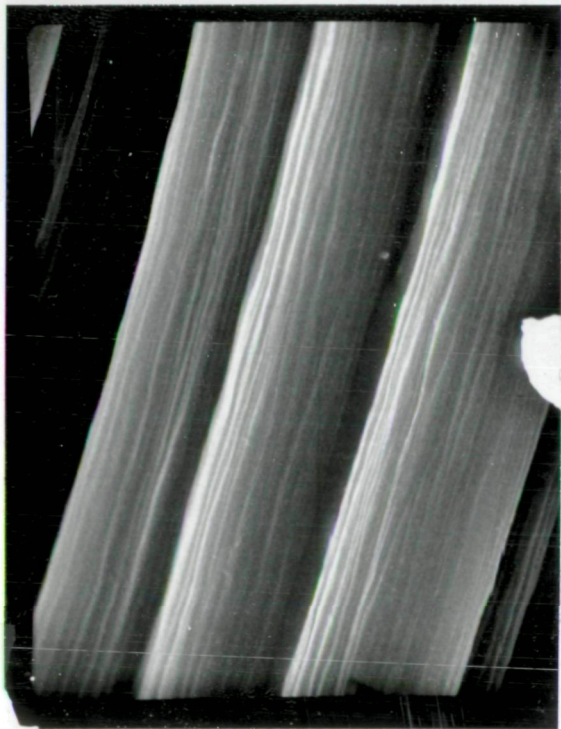
Fig. 4.1(a) UCC L-45 Silicone
Fluid, 8 wt.%,
Applied from Kerosene
Solution. 2000X

silicone fluids (Union Carbide Corporation Grade L-31). Coatings were applied from solvent based solutions. The coatings appeared very uniform, see Figure 4-1, and gave good bundle integrity to the yarn, see Figure 4-2. The uncoated control yarns can be seen in Figures 4-3 and 4-4. The coated yarn felt oily but handled well in the equipment. The coated yarns were static burn tested, see Figure 4-5. Figure 4-6 shows the uncoated control yarn after static burn testing. The silicones did not significantly affect fiber tensile strength or modulus but drastically reduced torsional shear strengths, see Table 4-1. The decrease in torsional shear strength results because the epoxy matrix material does not wet the silicone coated yarns. Changes in solvents and coating drying conditions did not change the nonwetting aspects of these systems. Since useful composites could not be fabricated using epoxies, no further work was done with silicone coatings.

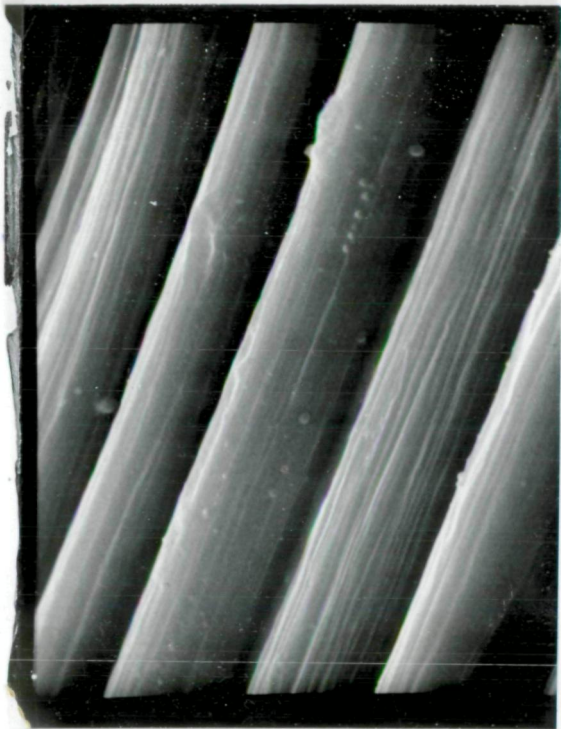
Fig. 4.1(b) UCC L-31 Silicone
Fluid, 5 wt. %,
Applied from Isopropanol
Solution. 2000x

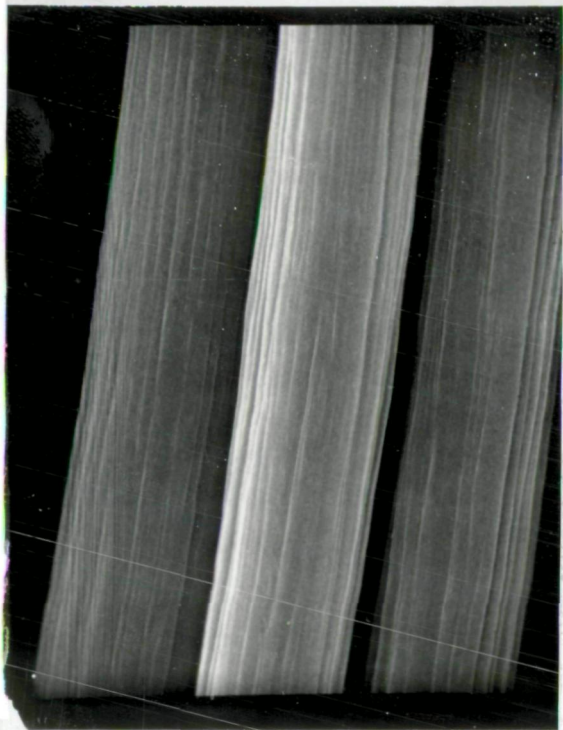
Fig. 4.3. SEM Micrograph of Uncoated
Water-Sized "Thornel" 300. 2000 X

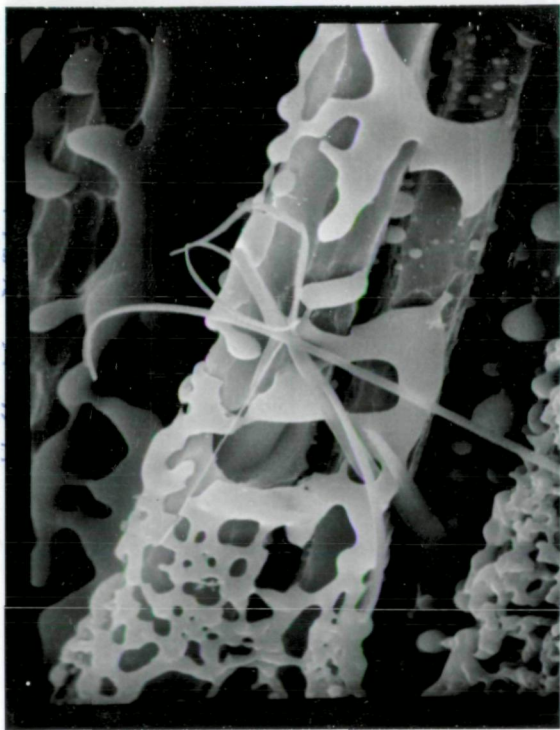
Fig. 4-5(a) UCC L-45 Silicone Fluid
Coating, 14 wt.%.2000X

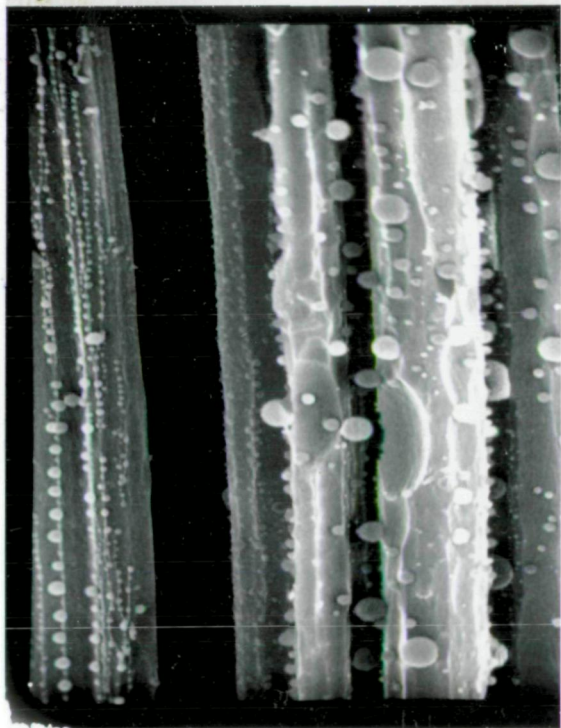
Fig. 4-5(b). UCC L-31 Silicone Fluid
Coating, 13 wt.%. 2000X

Fig. 4-5. Silicone Fluid Coated Carbon
Fibers After 1000⁰C Static Burn
for 30 Seconds.

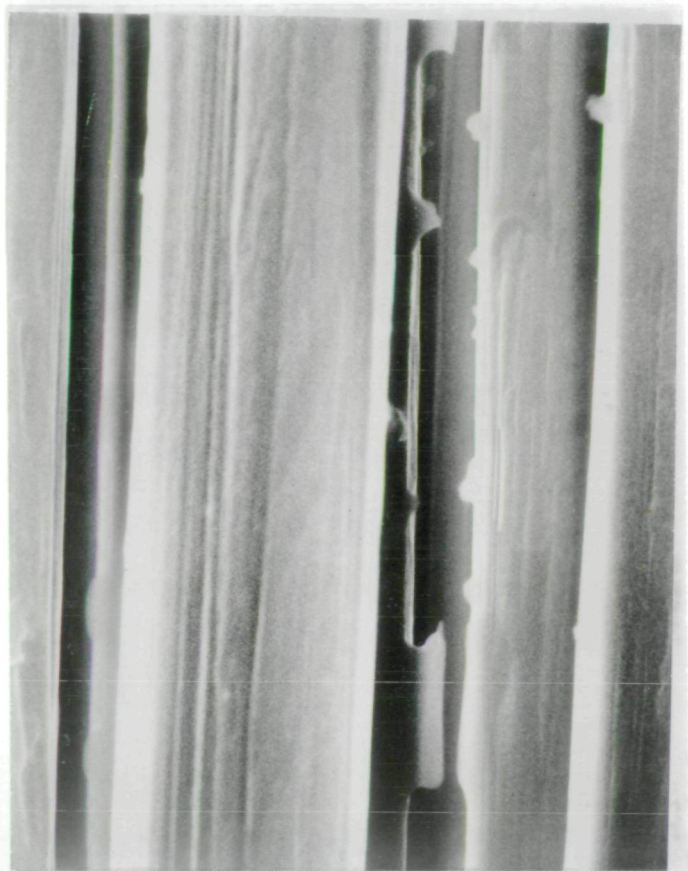
Fig. 4-7. SEM Micrograph of Boron Nitride,
from Ammonium Borate, Coating
on Carbon Fibers. 5000X

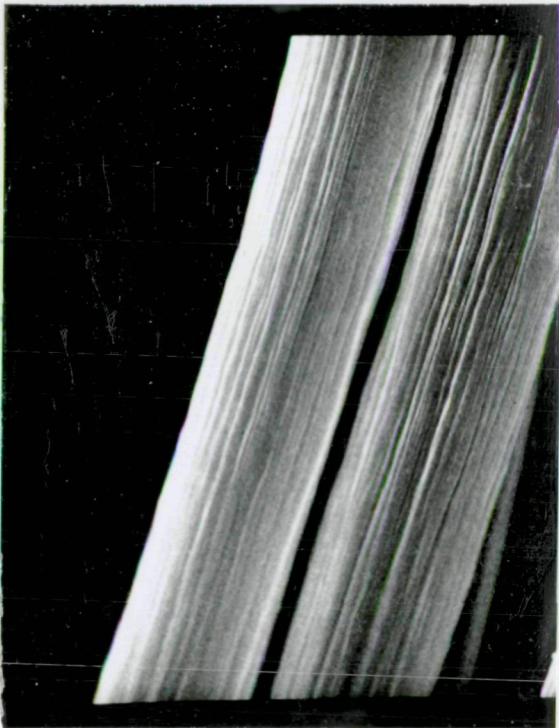
Fig. 4-8(a)

Fig. 4-8 (a) Boric Acid Coating, 5 wt.%.
2000X

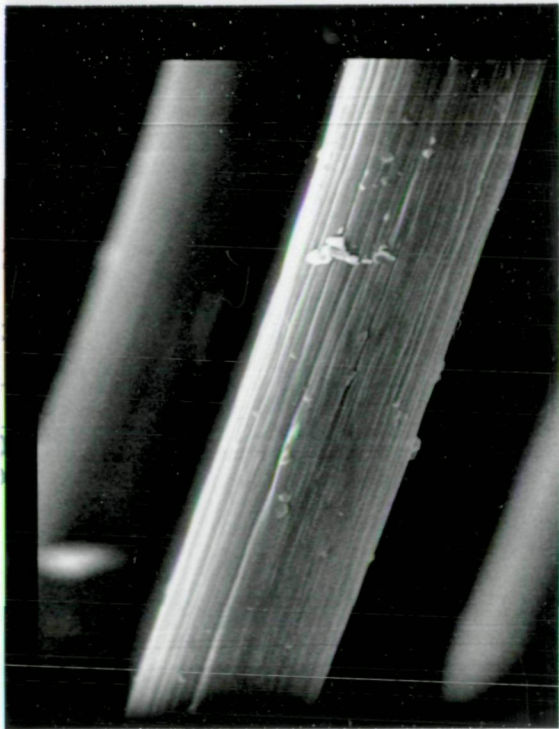
Fig. 4-8(b) Ammonium Borate Coating,
10 wt.%. 2000X

Fig. 4-8. SEM Micrographs of Coated
Carbon Fibers

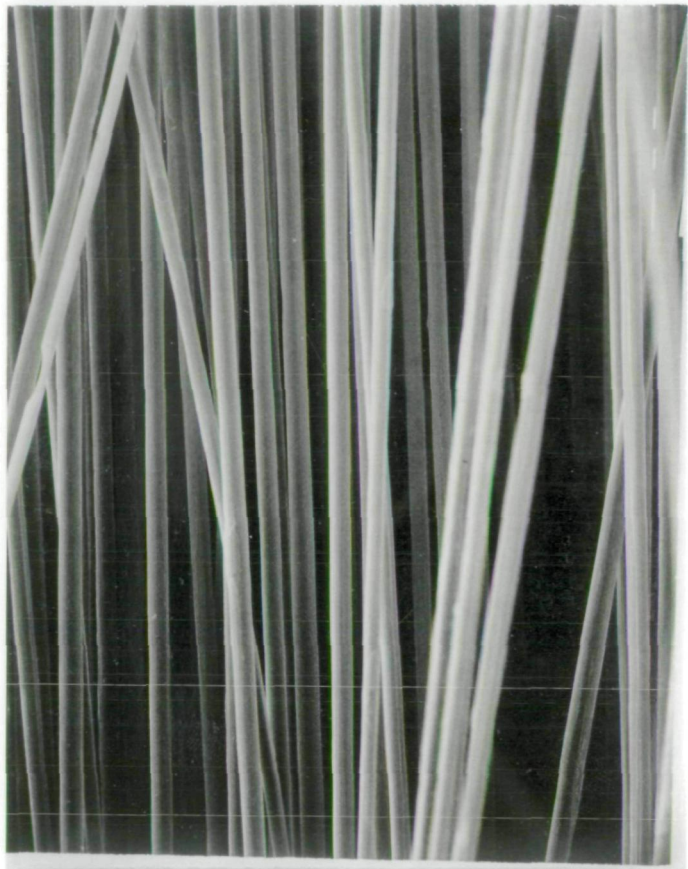
Fig.
4-9

Fig. 4-9. SEM Micrograph of Boron Nitride,
from Ammonium Borate, Coated
Carbon Fibers After 30 Seconds
Static Burn Test at 1000°C.
400X

Static burn testing of the coated yarn at 1000°C in air showed little fiber oxidation, Figure 4-9, which would be expected since the oxidation resistance of boron nitride is generally much better than carbon.

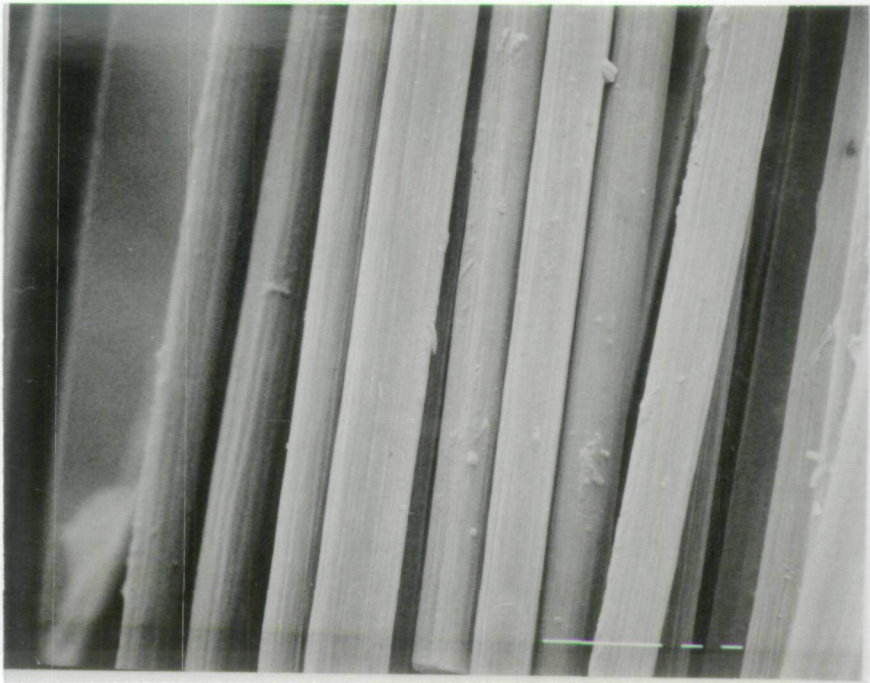
Fig. 4-10. SEM Micrograph of Boron Nitride
Coated Fiber Composite After
1000°C Static Burn Test for
30 Seconds. 1350X

Burn testing of composite materials made with boron nitride coated fibers was done in both the static and dynamic atmospheres. Composites burned at 1000°C in a static atmosphere oxidized slightly, see Figure 4-10. Composites made with water-sized fibers oxidized severely as can be seen in Figure 4-11. Composites burn tested dynamically also behaved similar to uncoated control samples. At these temperatures the boron nitride coatings protected the carbon fibers from oxidation but not to the extent seen in some of the other coatings. The dynamic burn test residues shown in Figure 4-12 contain epoxy char and the cooler the area of the sample examined, the more epoxy char was present. Figure 4-13 shows results of dynamic burn testing on a composite made with control yarn. In areas of the sample where temperatures were the hottest, very little epoxy char remained and the fiber oxidation was the most severe. The epoxy char holds carbon fibers together when the composite is burned at lower temperatures. At higher temperatures, when the epoxy char becomes minimal, the fibers themselves oxidize, so very little resultant fiber fly occurs. The amount of fibers released in the air and trapped by the filtration/collection system of the dynamic burn test chamber was so small that it could not be measured in the experiments reported on here.

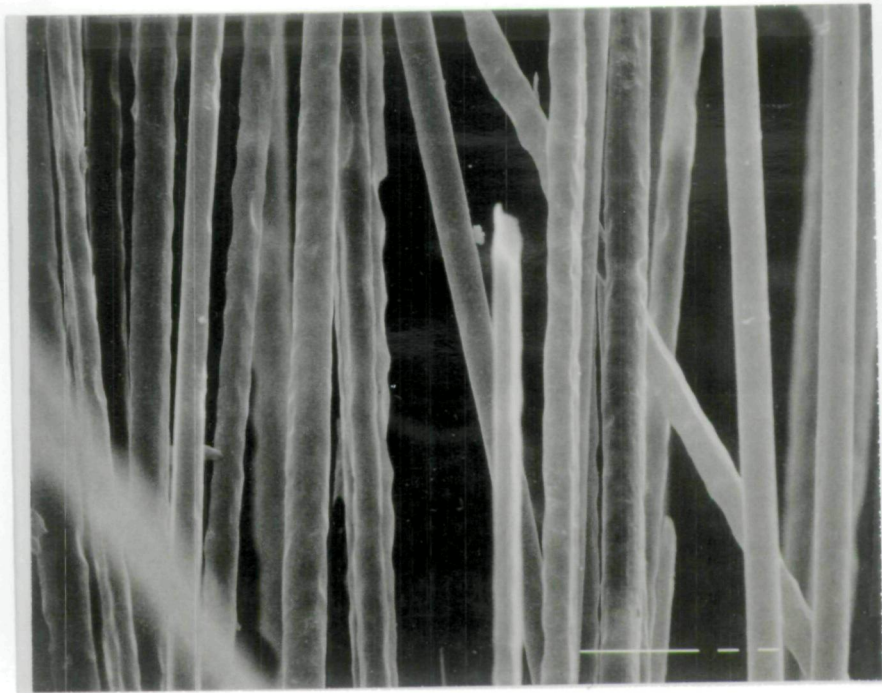
Fig. 4-11. SEM Micrograph of Water-Sized
"Thornel" 300 Fiber Composite
After 1000⁰C Static Burn Test
for 30 Seconds. 1200 X

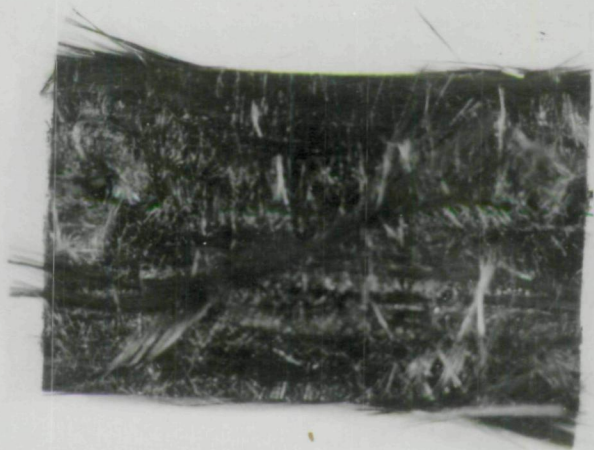
Fig. 4-12(a) Composite After 10 Minutes
Dynamic Burn Test, 850°C Max.,
1.5 x 10⁶ dyne·cm Impact
Energy, 12 M/sec. Air Velocity.
Scale is Centimeters.

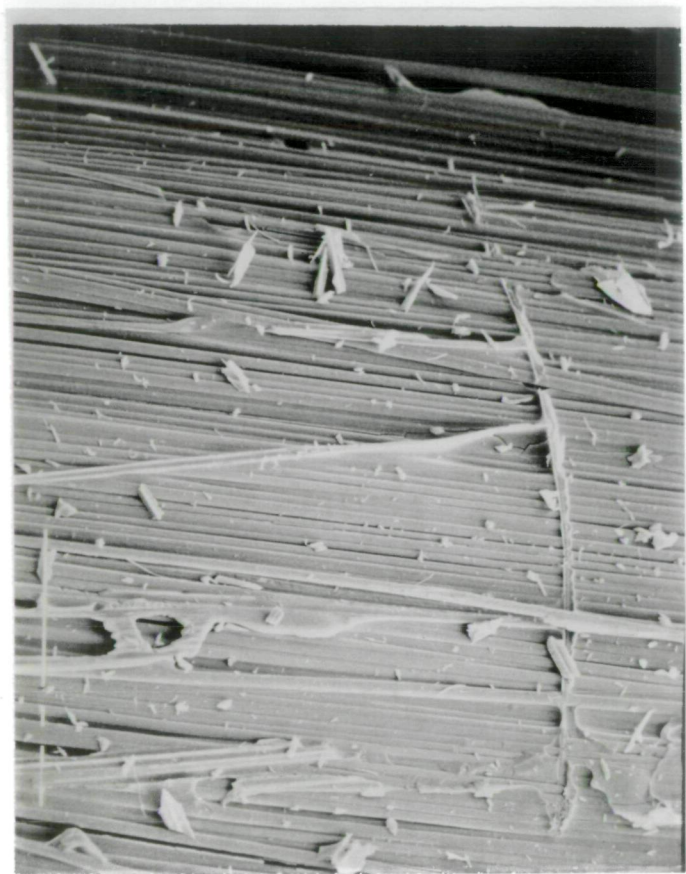
Fig. 4-12(b) SEM Micrograph from Cooler
Corner of Composite During
Burn Test. Epoxy Char is
Holding Fibers Together.
180X

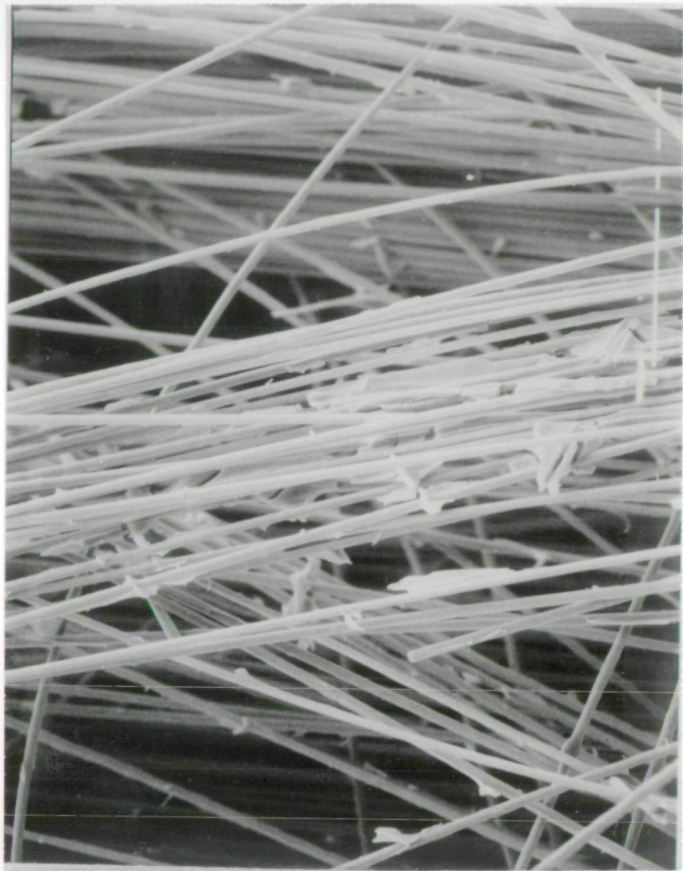
Fig. 4-12(c) SEM Micrograph from Hottest
Area of Composite Where
Fiber Burning was Taking
Place. 180X

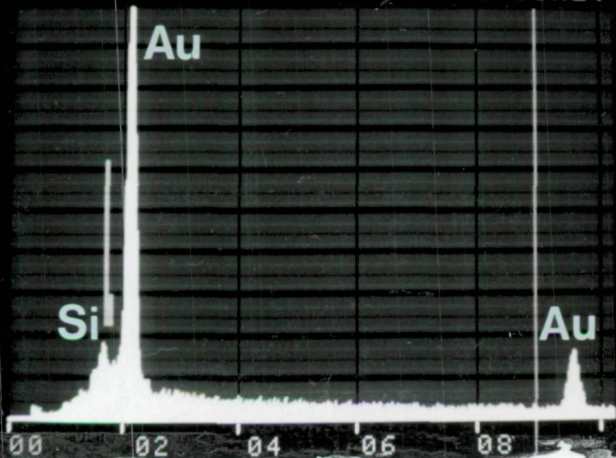
Fig. 4-12(d)

Fig. 4-12 (d) Kevex Trace of
Burned Composite Showing
Gold Coating and Small
Silicon Background.

Fig. 4-12. Boron Nitride,
from Ammonium Borate,
Coated Fiber Composite
After Dynamic Burn Test.

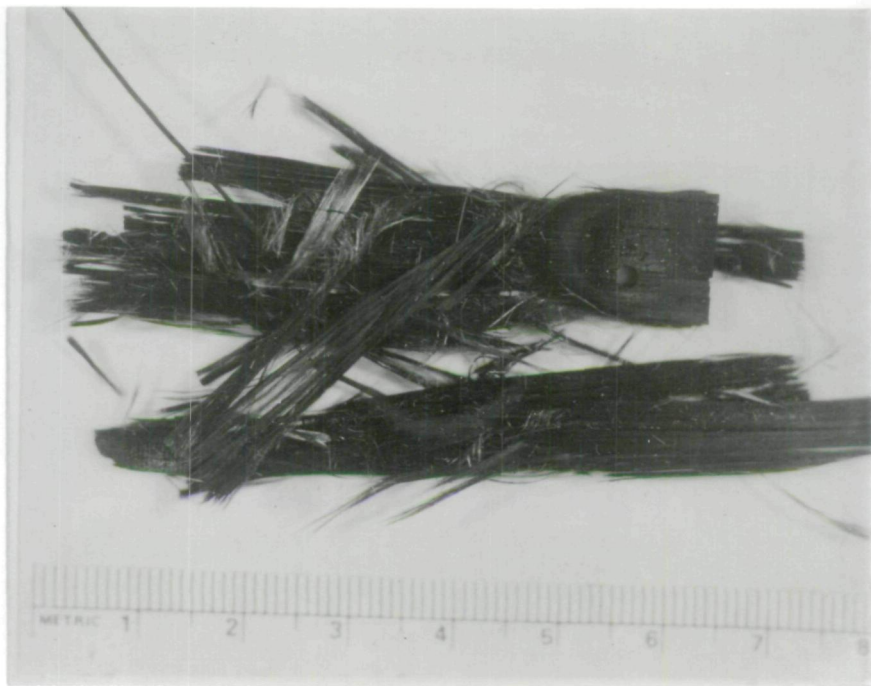
Fig. 4-13(a) Composite After 10 Minutes
Dynamic Burn Test, 850⁰C Max.,
1.5 x 10⁶ dyne·cm Impact Energy,
11 M/sec. Air Velocity. Approximately
60% of Fibers Burned Away.

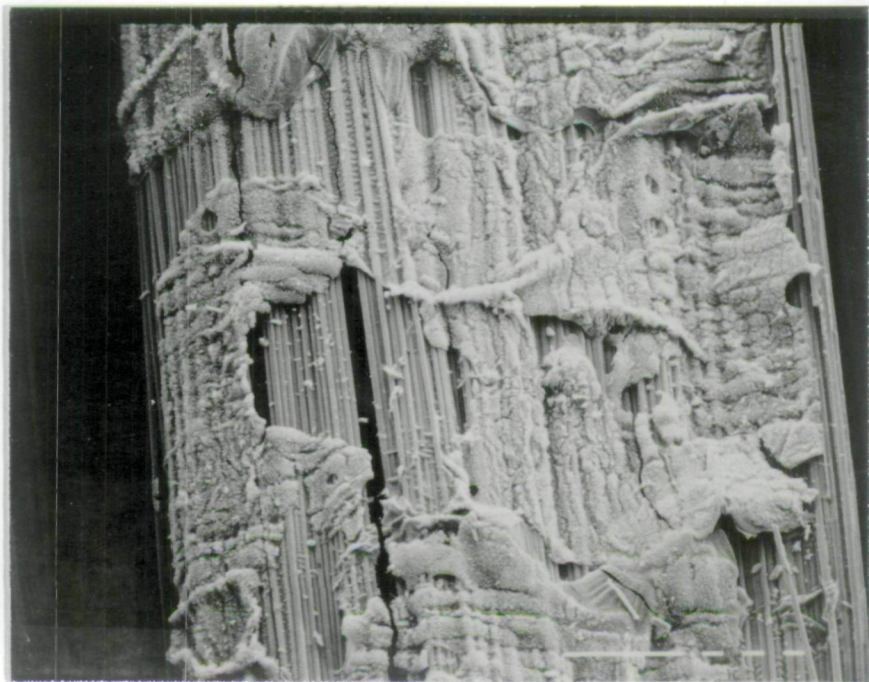
Fig. 4-13(b) SEM Micrograph from Cooler
Area of Composite During Burn Test.
Epoxy Char Holds Fibers Together.
120X

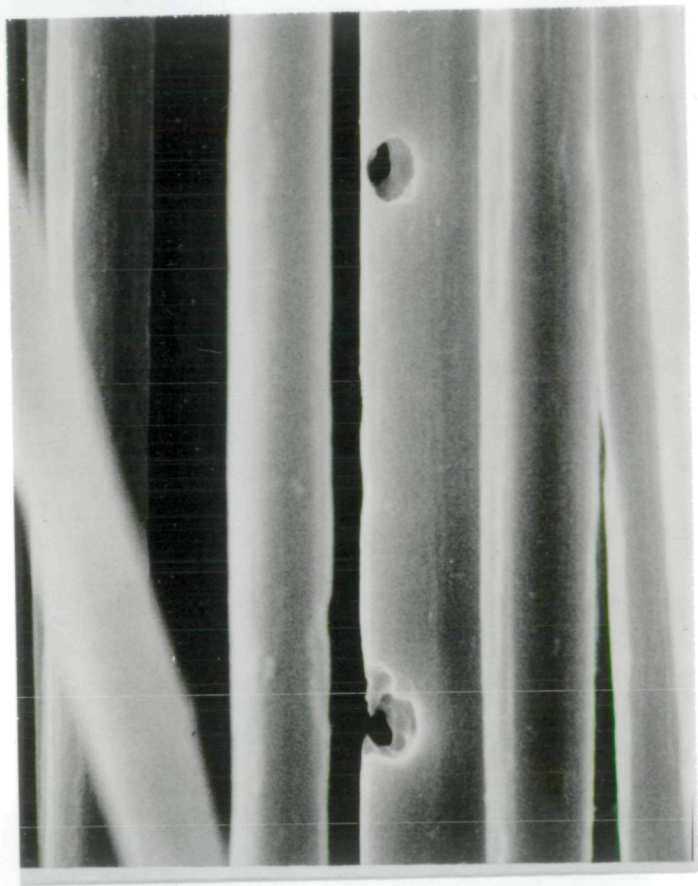
Fig. 4-13(c) SEM Micrograph of Fibers from
Hotter Area of Sample Where Fiber
Burning was Taking Place. 2700X

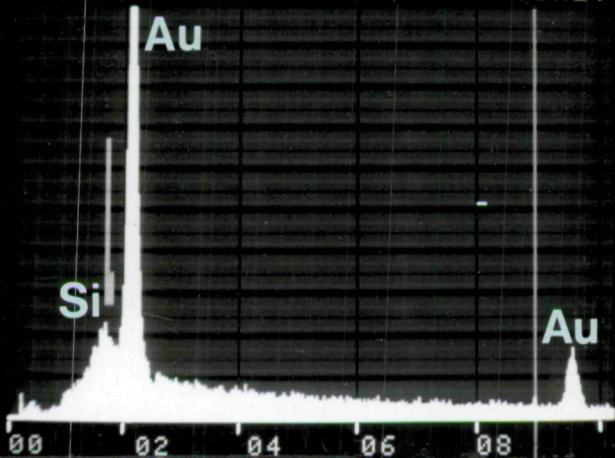
Fig. 4-13(d) Kevex Trace of
Burned Composite Showing
Gold Coating and Small
Silicon Background.

Fig. 4-13. Water-Sized "Thornel"
300 Fiber Composite After
Dynamic Burn Test.

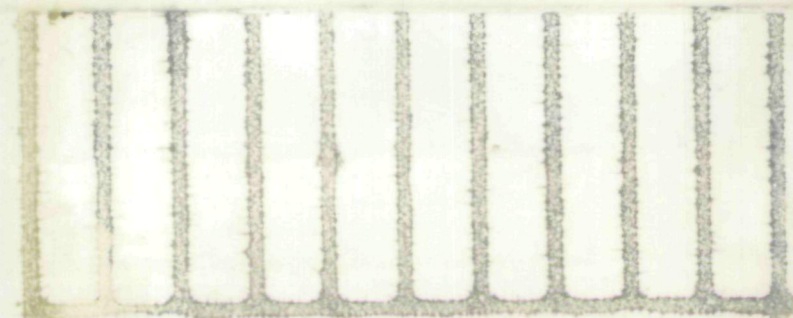
Fig. 4-14(a) Sodium Silicate Coated Fiber,
5 wt.%.

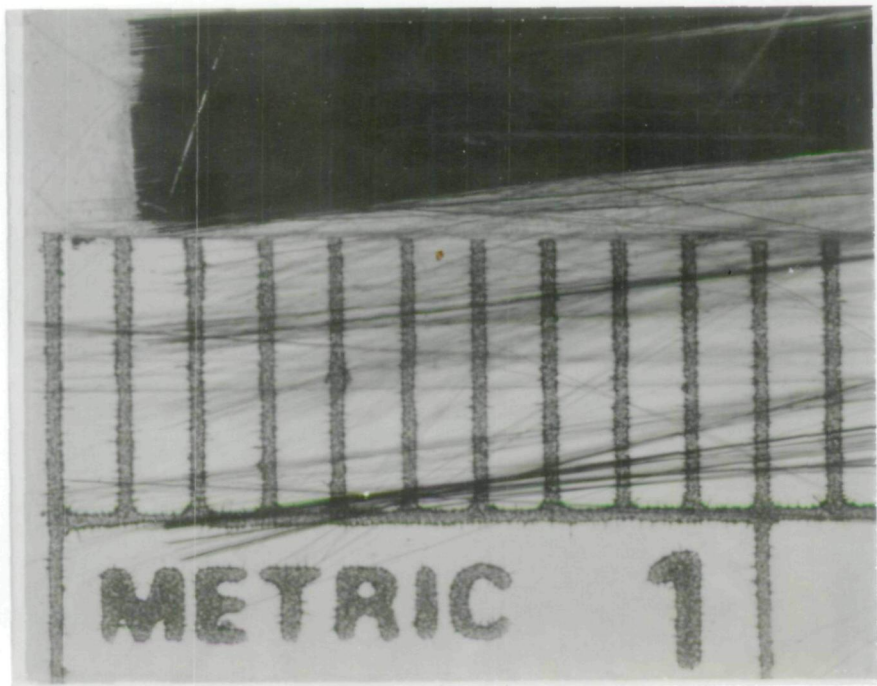
Fig. 4-14(d) Boric Acid Coated Fibers,
5 wt.%.

Fig. 4-14. Task III Fiber Coatings
Showing Bundle Integrity.
Scale is Centimeters.

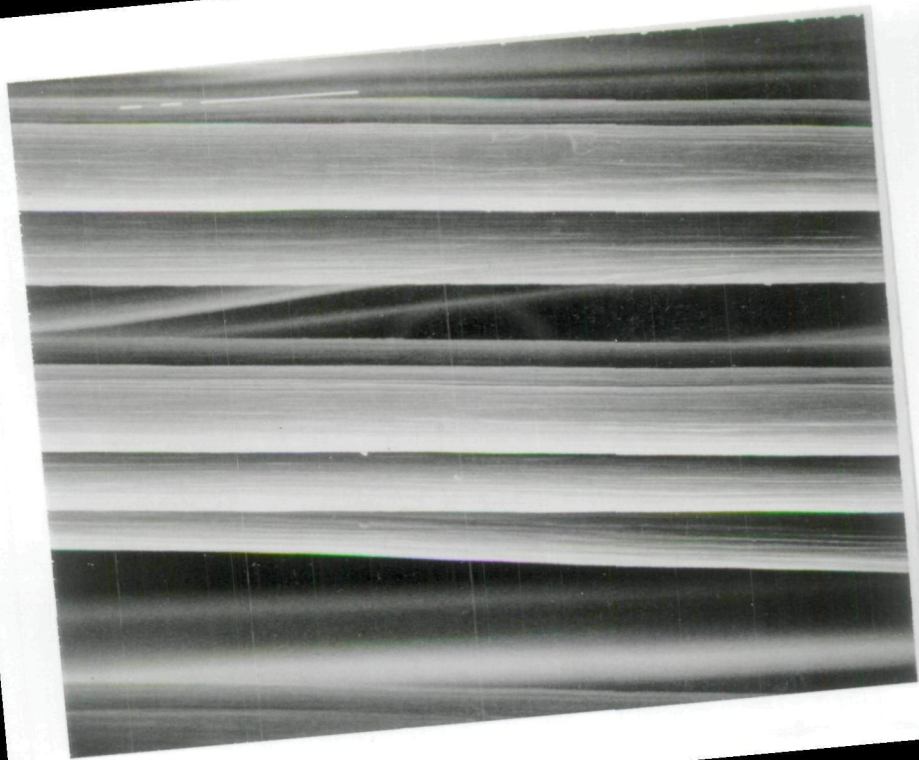
Fig. 4-15. SEM Micrograph of Ethyl Silicate, from an Isopropanol Solution, Coated Carbon Fibers.

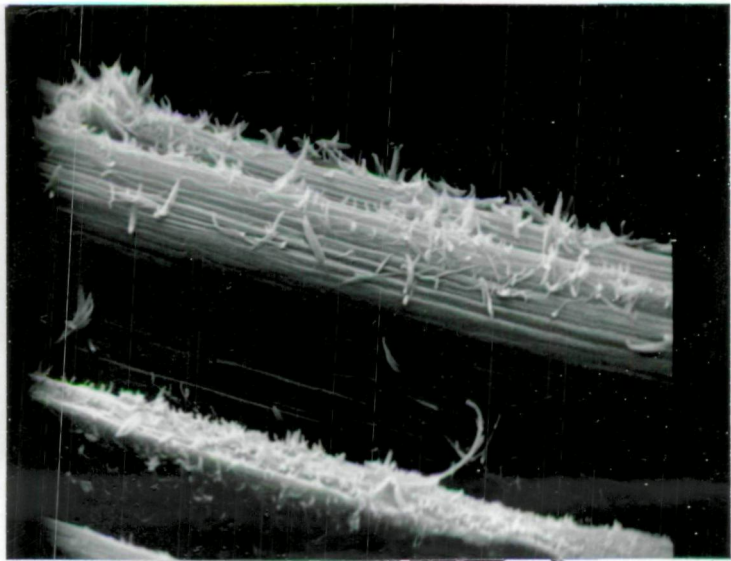
Fig. 4-16(a) Sodium Silicate,
10 wt.%, Coated Carbon
Fiber. 2000X

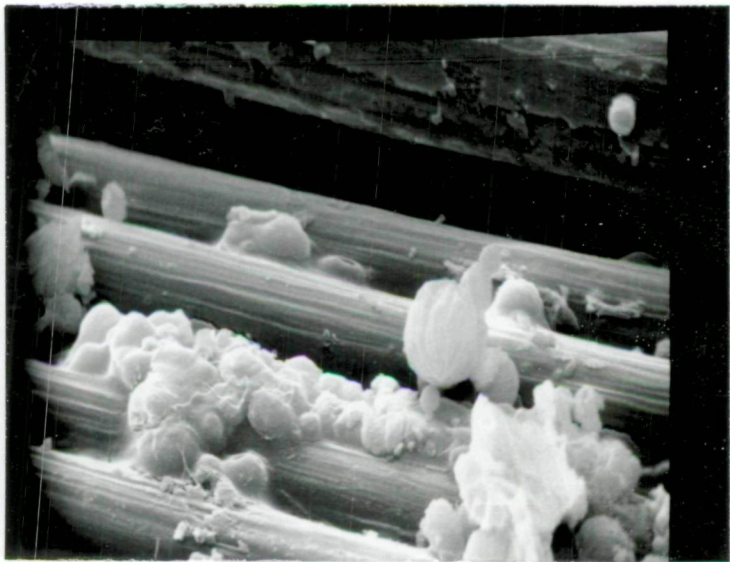
Fig. 4-16(b) Silica Gel, 6 wt.%,
Coated Carbon Fiber. 2000X

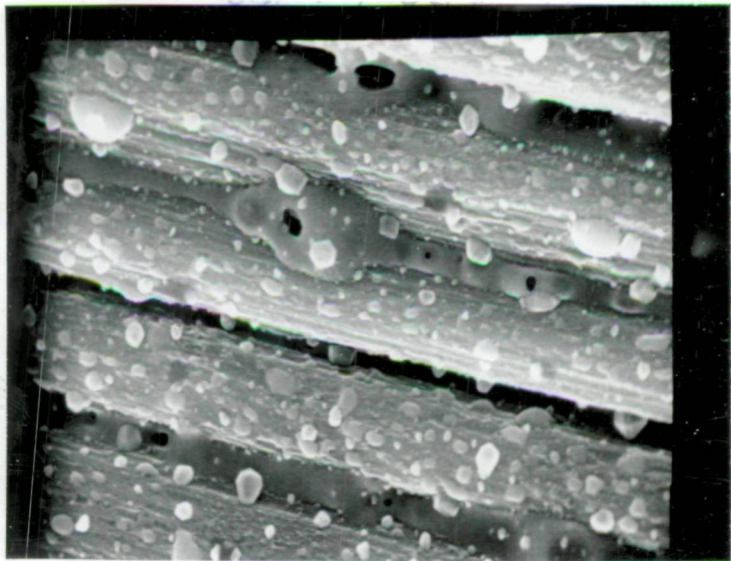
Fig. 4-17(a) Sodium Silicate,
10 wt.%, Coated Fibers.
2000 X

The coated fibers were static burn tested at 1000°C. As can be seen in Figure 4-17, most all of these coatings protected the fibers from oxidation except the ethyl silicate and to a smaller extent the silica gel. Since the sodium silicate coating protected the carbon fibers from oxidizing so well, the coating must be somewhat uniform but with regions of much thicker material, i.e., lumps, see Figure 4-16. The ethyl silicate coating must vaporize before it can form silica residues because the static burn tested fibers do not look significantly different than the uncoated control, Figure 4-6.

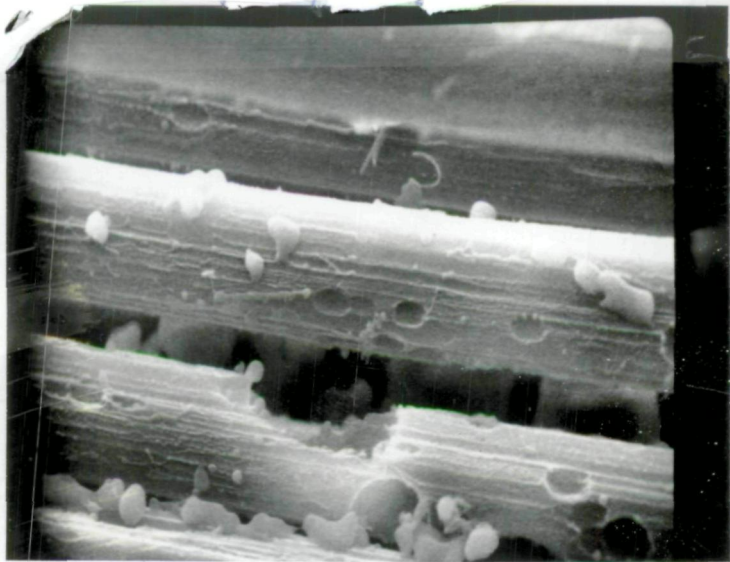
Fig. 4-17(b) Silica Gel, 6 wt.%,
Coated Fibers. 2000X

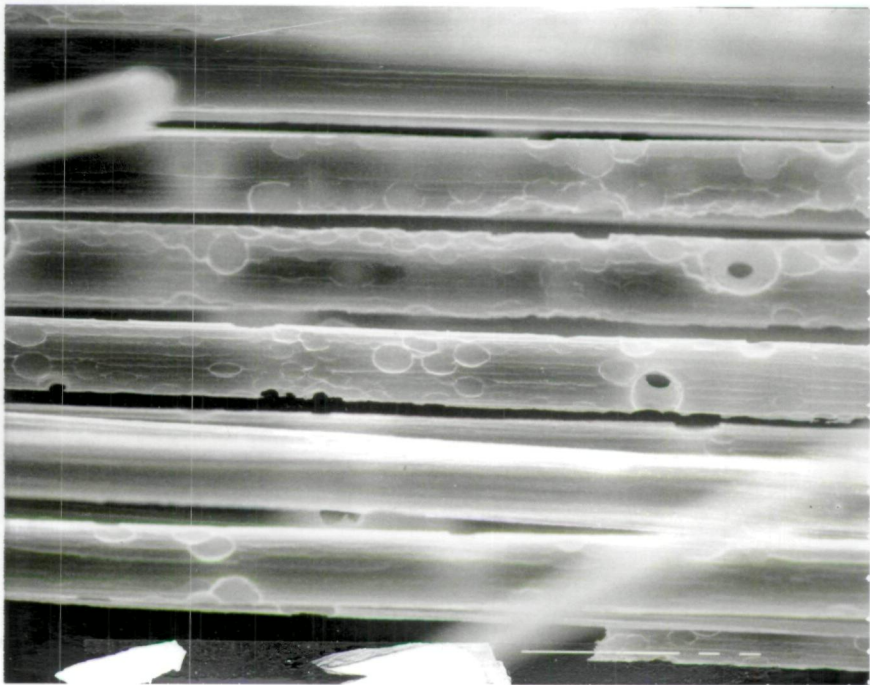
Fig. 4-17(c) Ethyl Silicate, 3.5 wt.%,
Coated Fibers. 1600X

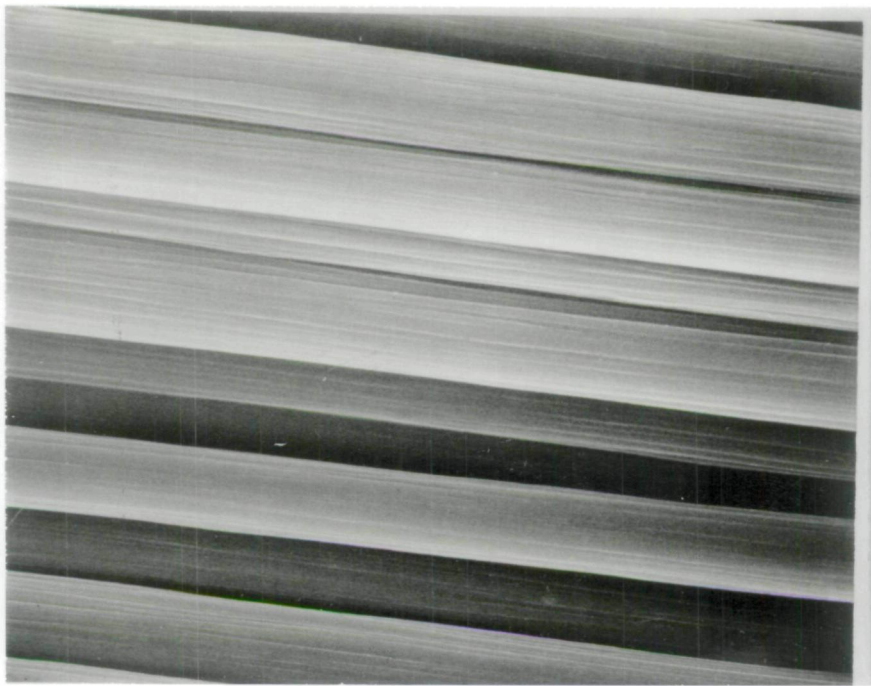
Fig. 4-17(d) Boric Acid, 7 wt.%,
Coated Fibers. 1800X

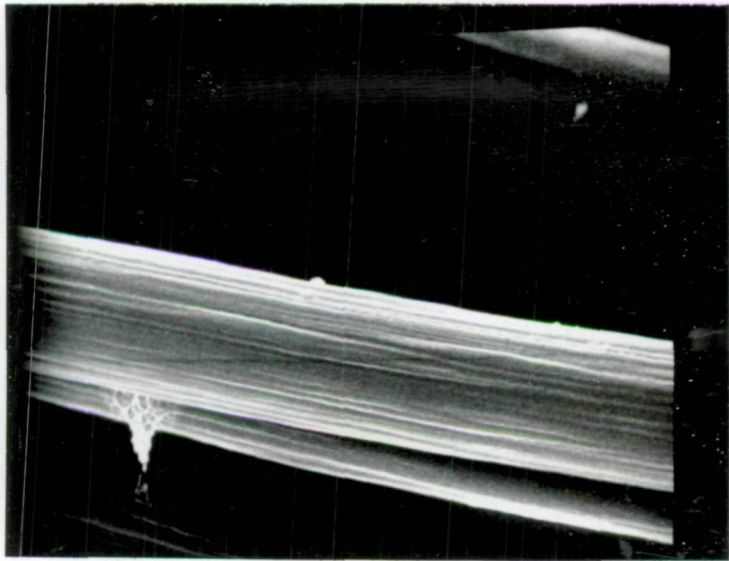
Fig. 4-17(d) Ammonium Borate,
10 wt.%, Coated Fibers.
2000X

Fig. 4-17. SEM Micrograph of
Task III Coatings on
Carbon Fibers After
1000^oC Static Burn Test
for 30 Seconds.

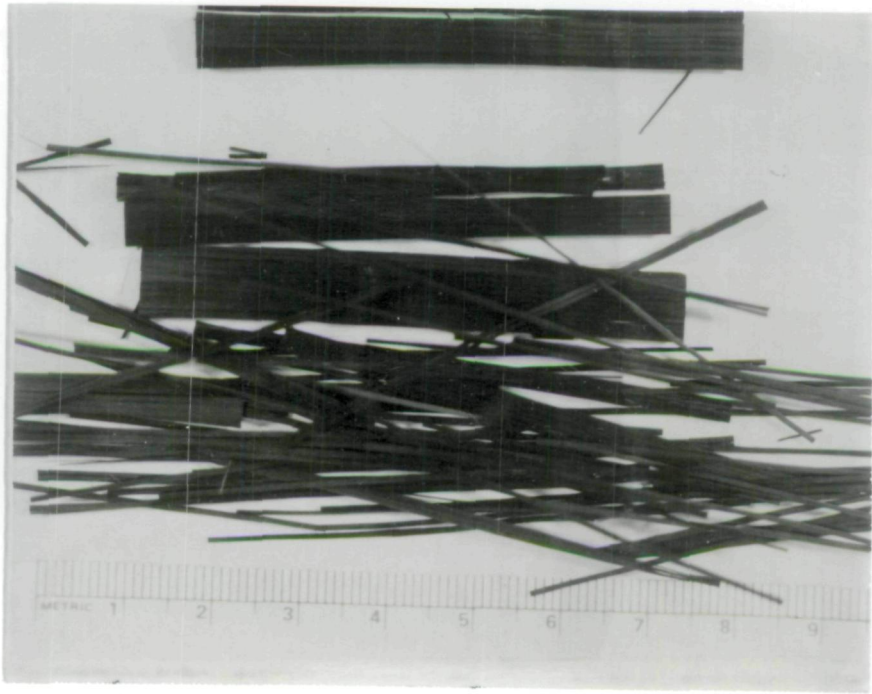
Fig. 4-18(a) Composite After 10 Minutes
Dynamic Burn Test, 850°C Max.,
1.5 x 10⁶ dyne·cm Impact
Energy, 12 M/sec. Air Velocity.
Scale is Centimeters.

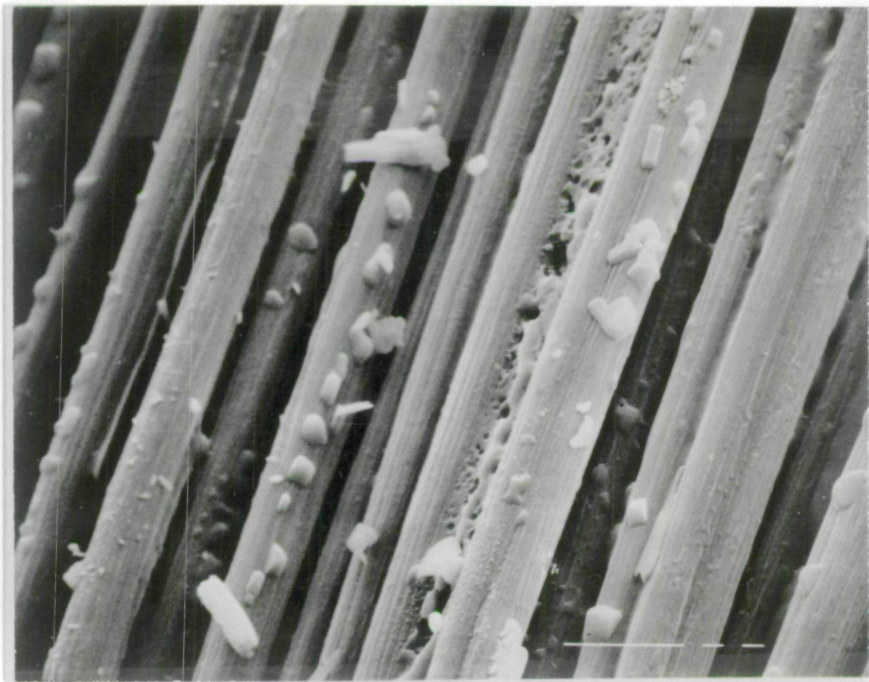
Fig. 4-18(b) SEM Micrograph from One of
Larger Pieces of Sample After
Burn Testing. 1350X

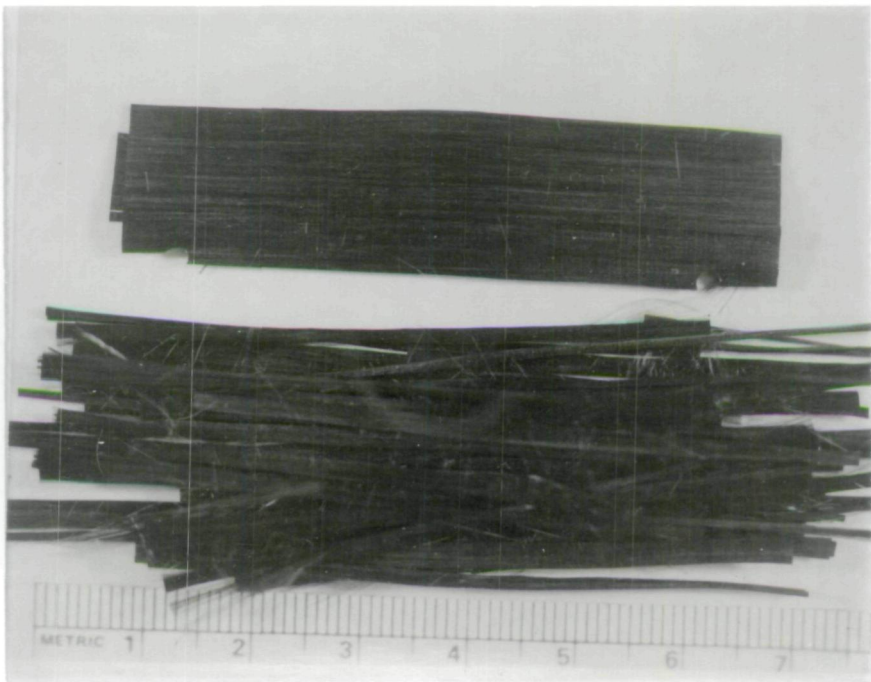
Fig. 4-19(a) Composite After 10 Minutes
Dynamic Burn Best, 850°C Max.,
1.5 x 10⁶ dyne·cm Impact Energy,
12 M/sec. Air Velocity. Scale is
Centimeters.

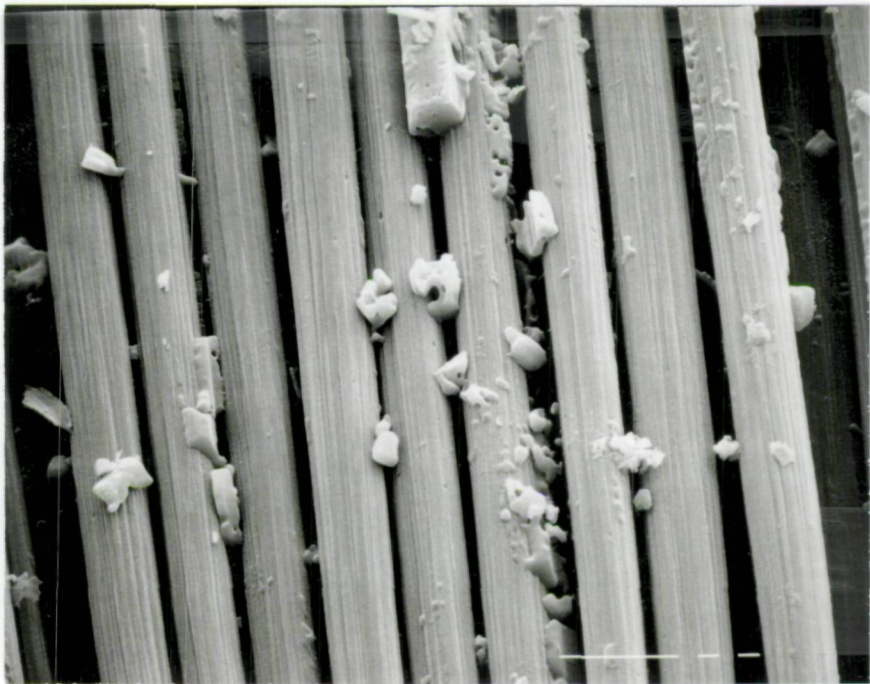
Fig. 4-19(b) SEM Micrograph from One of the
Smaller Fiber Bundles After Burn
Testing. 1350X
